**Flood Control Project Maintenance  
Levee Inspections**  
**LMA District Cover Sheet**  
**Spring 2017 Levee Inspection Results**

**Sacramento Maintenance Yard Maintenance Area 0009**

Waterway			Bank	Unit Miles
Unit No. 01 Sacramento River			Left	19.35
	Spring (March - May)	Summer (June - August)	(September - November) Fall	Winter (December - February)
Unit Maintenance Rating (Fall Only)				
Date of Inspection	4/25/2017 - 4/26/2017			
DWR Inspector	Zach Jojola			
Accompanied By	Dave Williams Sacramento Maintenance Yard

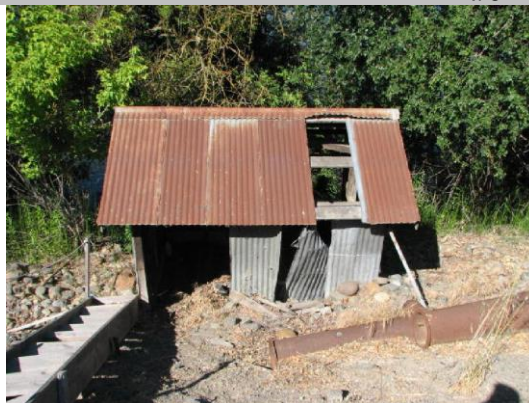
Photo 1 of 3 : UCIP\_SP\_2017\_51464\_20799.jpg

FS\_ID:51464  
DS\_ID:17469  
EP\_NO: N/A  
Repair Type: Urgent  
Crossing Status: Found  
UCIP Comments: 12/02/2016 same as previous inspection recommend internal integrity inspection to determine condition of pipe through the levee. Need to contact owner to determine status of crossing. If crossing is still in use or is no longer in use, owner will need to coordinate with the CVFPB to comply with Title 23. (O. Magana - DWR UCIP)06/25/2012 Pipe has leaks between valve and levee crown on both sides of levee. Ineffective repairs have been made. This pipe is an excellent candidate for video inspection. (W. Wylie - DWR UCIP) FIELD\_STRUCT\_DESC: 10-inch steel irrigation pipe through levee, 4.8 feet below crown. Pump in pumphouse located on the waterside (WS) slope, stairs located on both slopes. Gate valves on both ends. Service pole located on the landside (LS) slope. [Additional Reference(s): DWR Levee Log, 1991. USACE Sacramento O&M Manual Unit 111, May 1959, (River Mile 42.36)].

Pumphouse and stairs on WS slope.

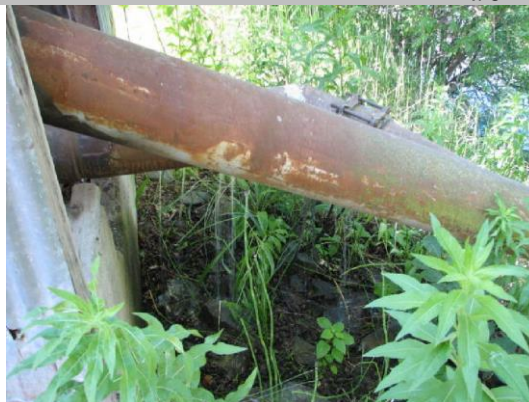
Photo 2 of 3 : UCIP\_SP\_2017\_51464\_20798.jpg

Holes/leaks in pipe on WS of Pumphouse.

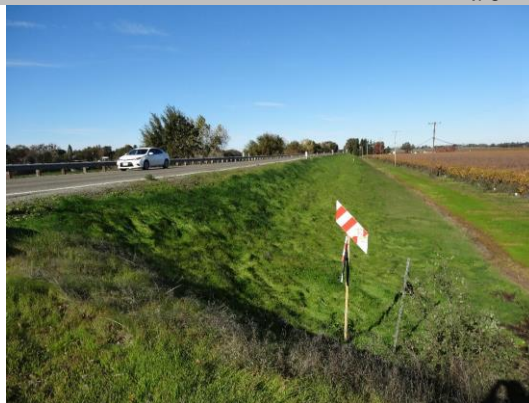
Photo 1 of 3 : UCIP\_SP\_2017\_51260\_76342.jpg

FS\_ID:51260  
DS\_ID:17471  
EP\_NO: N/A  
Repair Type: Urgent  
Crossing Status: Not Found  
UCIP Comments: 12/02/2016 Multiple PG&E markers were found along the LS toe. Line runs along LS toe for several miles and splits off main line at multiple locations. Need to coordinate with owner to determine where pipe crosses levee. Need to coordinate with PG&E to determine if crossing goes through the levee or if line goes along LS toe only. (O. Magana - DWR UCIP)06/25/2012 Pipe not found and no markers found. Further investigation should be conducted to locate gasoline. (W. Wylie - DWR UCIP)  
FIELD\_STRUCT\_DESC: 6-inch high pressure gasoline of unknown material through levee and across channel at unknown depth.  
[Additional Reference(s): DWR Levee Log, 1991].  
FS Date: 12/2/2016

View of PG&E markers located where pipe is assumed to be.

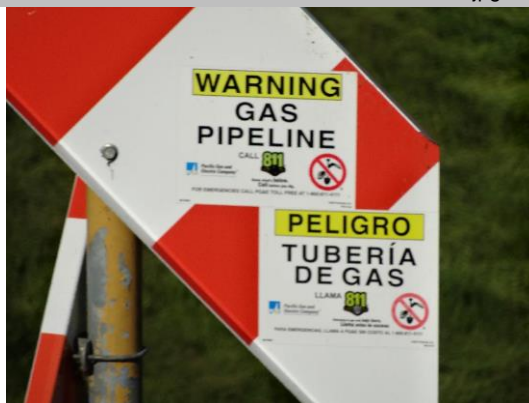
Photo 2 of 3 : UCIP\_SP\_2017\_51260\_76343.jpg

PG&E line markers visible along LS toe.

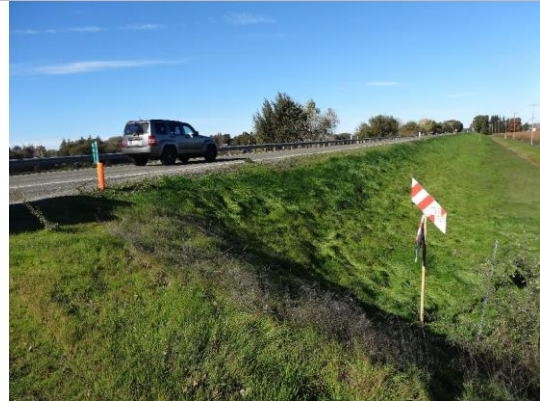
Photo 3 of 3 : UCIP\_SP\_2017\_51260\_76344.jpg

Item	DWR UCIP Field Study			38.418110 °	38.418110 °	
				-121.522470 °	-121.522470 °	
DWR ID						
Comment Code						
Inspector Comment						
FS_ID:51260 DS_ID:17471 EP_NO: N/A Repair Type: Urgent Crossing Status: Not Found UCIP Comments: 12/02/2016 Multiple PG&E markers were found along the LS toe. Line runs along LS toe for several miles and splits off main line at multiple locations. Need to coordinate with owner to determine where pipe crosses levee. Need to coordinate with PG&E to determine if crossing goes through the levee or if line goes along LS toe only. (O. Magana - DWR UCIP)06/25/2012 Pipe not found and no markers found. Further investigation should be conducted to locate gasoline. (W. Wylie - DWR UCIP) FIELD_STRUCT_DESC: 6-inch high pressure gasoline of unknown material through levee and across channel at unknown depth. [Additional Reference(s): DWR Levee Log, 1991]. FS Date: 12/2/2016

View of levee crown at crossing.

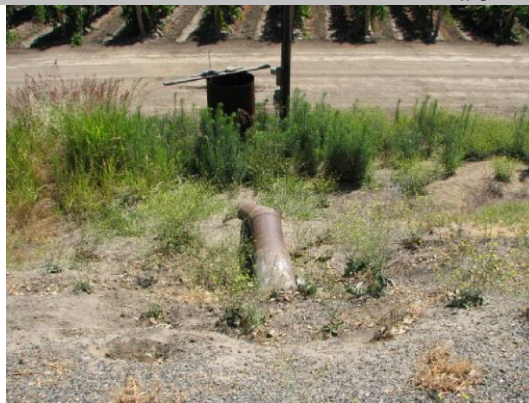
Photo 2 of 3 : UCIP\_SP\_2017\_5172\_6982.jpg

LM Start	13.85	Rating **	M	Issue No.	1823 (cont)
LM End	13.85	Issue Type +	En	Location *	WS
Category	Supplemental			GPS Latitude/Longitude	
				Start	End
Item	DWR UCIP Field Study			38.416180 °	38.416180 °
				-121.521083 °	-121.521083 °
DWR ID					
Comment Code					
Inspector Comment					
FS_ID:5172 DS_ID:17474 EP_NO: N/A Repair Type: Non-Urgent Crossing Status: Found UCIP Comments: Rodent undermining pipe on LS slope. Need to fill burrow with flowable fill. FIELD_STRUCT_DESC: 14-inch pipe through levee, 5.2 feet below crown. 12-inch sleeved through 14-inch with annular space grouted. Pump and gate valve in pumphouse on waterward slope. Service pole on landward slope. 36-inch steel standpipe at toe of landward slope. Originally included in O+M manual (1955). 1.5-inch steel electrical conduit through levee and parallel to 14-inch pipe. FS Date: 6/25/2012 10:08:16 AM

36-inch standpipe, JP, and meter on LS toe.

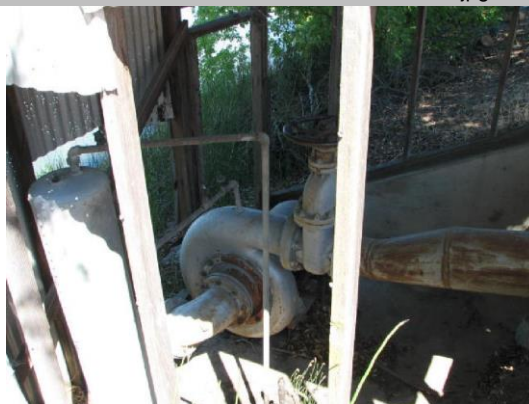
Photo 3 of 3 : UCIP\_SP\_2017\_5172\_6981.jpg

Pump and gate valve in pumphouse on WS slope.

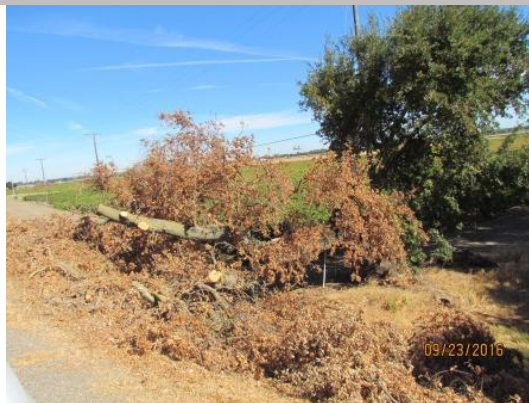
Photo 1 of 1 : SP\_2017\_MA0009\_201\_261\_20170320\_00202.jpg

LM Start	13.94	Rating **	M	Issue No.	261
LM End	13.94	Issue Type +	En	Location *	LS
Category	Earthen Levee			GPS Latitude/Longitude	
				Start	End
Item	Encroachments			38.415112 °	38.415112 °
				-121.520226 °	-121.520226 °
DWR ID	DWR_MA0009_01_f_2016_261				
Comment Code					
PR : Prunings					
Inspector Comment

Prunings and tree body on landside slope looking upstream.

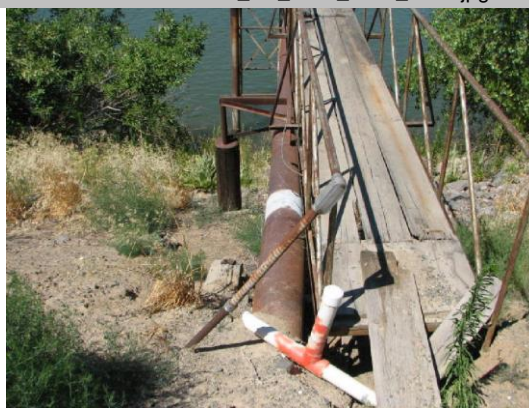
Photo 1 of 3 : UCIP\_SP\_2017\_5174\_6987.jpg

Comment Code					
Inspector Comment					
FS_ID:5174 DS_ID:17475 EP_NO: N/A Repair Type: Non-Urgent Crossing Status: Found UCIP Comments: Annular space between 12-inch and 14-inch pipes needs to be grouted. Siphon breaker on LS shoulder appears to be damaged. No permit identified for this crossing and it is not noted in the O+M manual. FIELD_STRUCT_DESC: 14-inch pipe through levee, 2.6 feet below crown. 12-inch pipe on WS connected to 14-inch pipe through levee. Pump on pile structure in stream. 1.5-inch steel electrical conduit through levee and parallel to 14-inch pipe. Siphon breaker in 24-inch CMP riser on LS shoulder. Pole, meter, and 36-inch concrete standpipe on LS toe. Permit No. 1835, 1953. FS Date: 6/25/2012 10:19:35 AM

12-inch steel pipe through 14-inch steel conduit on WS shoulder at pier.  
1.5-inch steel electrical conduit.

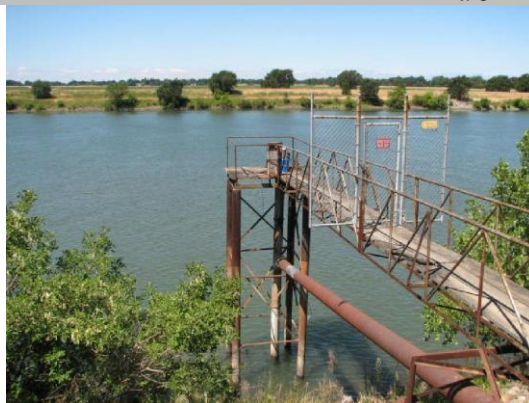
Photo 2 of 3 : UCIP\_SP\_2017\_5174\_6986.jpg

Comment Code					
Inspector Comment					
FS_ID:5174 DS_ID:17475 EP_NO: N/A Repair Type: Non-Urgent Crossing Status: Found UCIP Comments: Annular space between 12-inch and 14-inch pipes needs to be grouted. Siphon breaker on LS shoulder appears to be damaged. No permit identified for this crossing and it is not noted in the O+M manual. FIELD_STRUCT_DESC: 14-inch pipe through levee, 2.6 feet below crown. 12-inch pipe on WS connected to 14-inch pipe through levee. Pump on pile structure in stream. 1.5-inch steel electrical conduit through levee and parallel to 14-inch pipe. Siphon breaker in 24-inch CMP riser on LS shoulder. Pole, meter, and 36-inch concrete standpipe on LS toe. Permit No. 1835, 1953. FS Date: 6/25/2012 10:19:35 AM

12-inch pipe on pier WS.

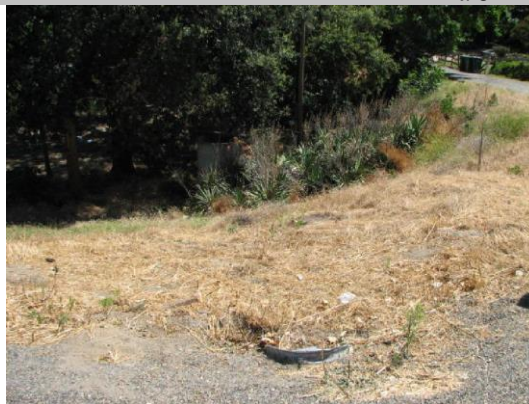
Photo 3 of 3 : UCIP\_SP\_2017\_5174\_6985.jpg

siphon breaker in damaged 24-inch CMP riser on LS shoulder (in foreground)

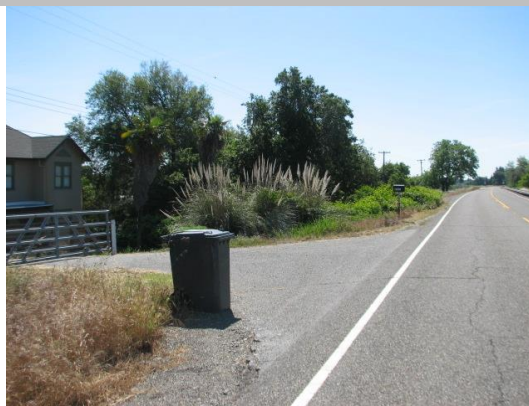
Photo 1 of 2 : SP\_2017\_MA0009\_201\_205\_20170320\_00166.jpg

LM Start	14.27	Rating **	M	Issue No.	205
LM End	14.27	Issue Type +	En	Location *	LS
Category	Earthen Levee			GPS Latitude/Longitude	
				Start	End
Item	Vegetation			38.410947 °	38.410947 °
				-121.517202 °	-121.517202 °
DWR ID	DWR_MA0009_01_s_2012_205				
Comment Code					
V6 : Landscaping					
Inspector Comment

Looking downstream at the landscaping on the levee slope. Spring 2014

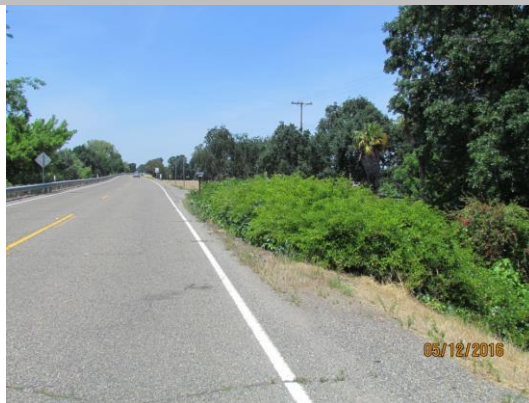
Photo 2 of 2 : SP\_2017\_MA0009\_201\_205\_20170320\_00167.jpg

View of the shrubs on the landward side of the levee looking upstream. Spring 2016.

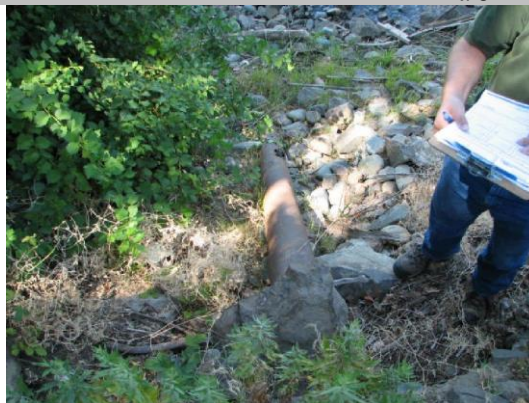
Photo 1 of 1 : UCIP\_SP\_2017\_5175\_6989.jpg

LM Start	14.28	Rating **	M	Issue No.	1825
LM End	14.28	Issue Type +	En	Location *	LS
Category	Supplemental			GPS Latitude/Longitude	
				Start	End
Item	DWR UCIP Field Study			38.410811 °	38.410811 °
				-121.517144 °	-121.517144 °
DWR ID					
Comment Code					
Inspector Comment					
FS_ID:5175 DS_ID:17575 EP_NO: N/A Repair Type: Non-Urgent Crossing Status: Found UCIP Comments: Type of abandonment needs to be determined. FIELD_STRUCT_DESC: 6-inch pipe through the levee 6.1-feet below the crown and visible on WS toe. Pump on water side removed. Originally included in O+M manual (1955). FS Date: 6/25/2012 10:35:04 AM

cut-off pipe at WS toe/slope. No indication pipe goes through levee.

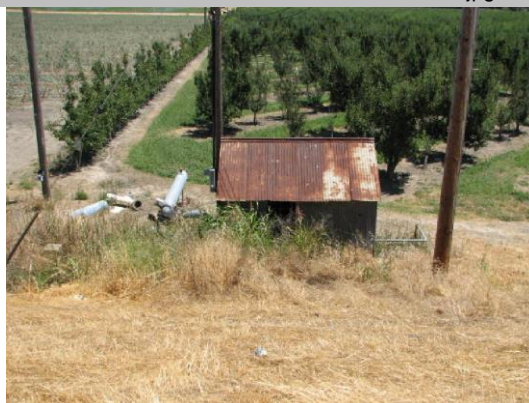
Photo 1 of 3 : UCIP\_SP\_2017\_51704\_6999.jpg

LM Start	14.64	Rating **	U	Issue No.	1826
LM End	14.64	Issue Type +	En	Location *	LS
Category	Supplemental			GPS Latitude/Longitude	
				Start	End
Item	DWR UCIP Field Study			38.406118 °	38.406118 °
				-121.514463 °	-121.514463 °
DWR ID					
Comment Code					
Inspector Comment					
FS_ID:51704					
DS_ID:17466					
EP_NO: N/A					
Repair Type: Urgent					
Crossing Status: Found					
UCIP Comments: 04/26/2017 As per DWR inspector, Zack Jojola, the pump associated with this pipe appears to be leaking. Crossing has been upgraded from No Action Needed to Urgent. (K. Fazel - UCIP)					
FIELD_STRUCT_DESC: 12-inch pipe through levee, 10.5 feet below crown. Pump on pumphouse on landward side. Originally included in O+M manual (1955). JP and meter at LS toe.					
FS Date: 4/26/2017 11:17:00 AM

Pumphouse, JP, and meter on LS toe.

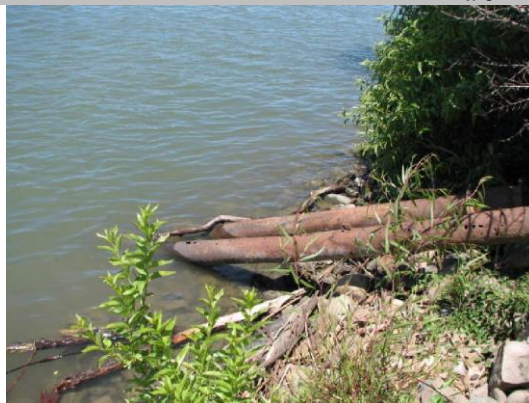
Photo 2 of 3 : UCIP\_SP\_2017\_51704\_6998.jpg

LM Start	14.64	Rating **	U	Issue No.	1826 (cont)	
LM End	14.64	Issue Type +	En	Location *	LS	
Category	Supplemental			GPS Latitude/Longitude		
				Start	End	
Item	DWR UCIP Field Study			38.406118 °	38.406118 °	
				-121.514463 °	-121.514463 °	
DWR ID						
Comment Code						
Inspector Comment						
FS_ID:51704						
DS_ID:17466						
EP_NO: N/A						
Repair Type: Urgent						
Crossing Status: Found						
UCIP Comments: 04/26/2017 As per DWR inspector, Zack Jojola, the pump associated with this pipe appears to be leaking. Crossing has been upgraded from No Action Needed to Urgent. (K. Fazel - UCIP)						
FIELD_STRUCT_DESC: 12-inch pipe through levee, 10.5 feet below crown. Pump on pumphouse on landward side. Originally included in O+M manual (1955). JP and meter at LS toe.						
FS Date: 4/26/2017 11:17:00 AM

8-inch pipe and discarded 8-inch pipe on WS toe.

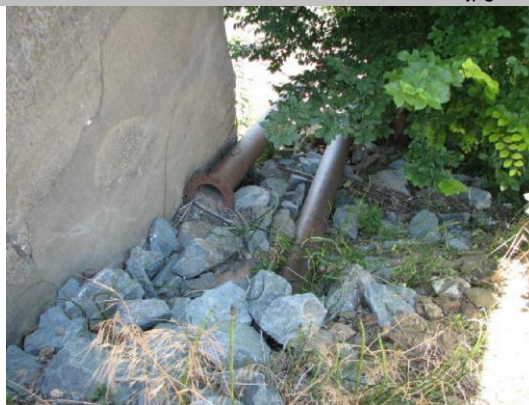
Photo 3 of 3 : UCIP\_SP\_2017\_51704\_7001.jpg

8-inch pipe at US side of concrete pumphouse.

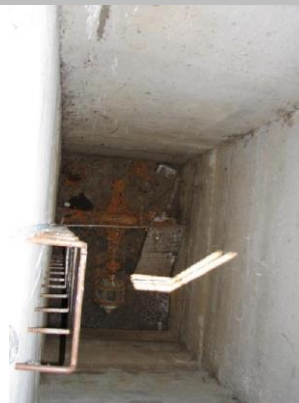
Photo 1 of 3 : UCIP\_SP\_2017\_51705\_6995.jpg

FS\_ID:51705  
DS\_ID:17441  
EP\_NO: N/A  
Repair Type: Urgent  
Crossing Status: Found  
UCIP Comments: 04/26/2017 04/26/2017 As per DWR inspector, Zack Jojola, the pump associated with this pipe appears to be leaking. Crossing has been upgraded from No Action Needed to Urgent. (K. Fazel - UCIP)06/25/2012 Further evaluation should be conducted to determine if 12-inch pipe through levee has been properly abandoned. Pipe rusted through at bottom of pumphouse. (G. Wylie - FPIIB)  
FIELD\_STRUCT\_DESC: \*ABANDONED\* 12-inch pipe through levee, 9.5 feet below crown. Concrete pumphouse with pump and gate valve at bottom of pit on WS slope. Steel plate welded on waterward end could not be verified or found. Originally included in O+M manual (1955).  
FS Date: 4/26/2017 10:52:00 AM

Pump, pipe, and gate valve at bottom of pit in pumphouse.

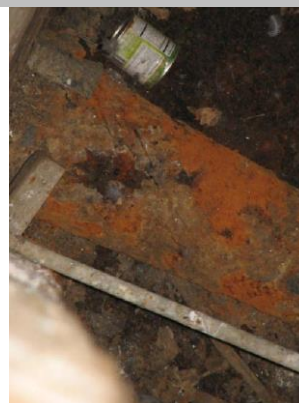
Photo 2 of 3 : UCIP\_SP\_2017\_51705\_6994.jpg

Pipe appears to be severely corroded at bottom of pumphouse pit.

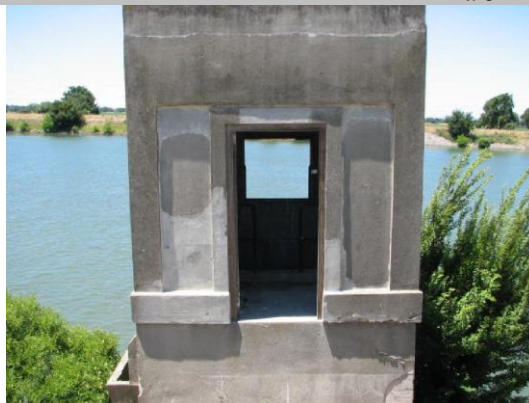
Photo 3 of 3 : UCIP\_SP\_2017\_51705\_6993.jpg

Item	DWR UCIP Field Study			38.406099 °	38.406099 °	
				-121.514458 °	-121.514458 °	
DWR ID						
Comment Code						
Inspector Comment						
FS_ID:51705						
DS_ID:17441						
EP_NO: N/A						
Repair Type: Urgent						
Crossing Status: Found						
UCIP Comments: 04/26/2017 04/26/2017 As per DWR inspector, Zack Jojola, the pump associated with this pipe appears to be leaking. Crossing has been upgraded from No Action Needed to Urgent. (K. Fazel - UCIP)06/25/2012 Further evaluation should be conducted to determine if 12-inch pipe through levee has been properly abandoned. Pipe rusted through at bottom of pumphouse. (G. Wylie - FPIIB) FIELD_STRUCT_DESC: *ABANDONED* 12-inch pipe through levee, 9.5 feet below crown. Concrete pumphouse with pump and gate valve at bottom of pit on WS slope. Steel plate welded on waterward end could not be verified or found. Originally included in O+M manual (1955).

Pumphouse on WS slope.

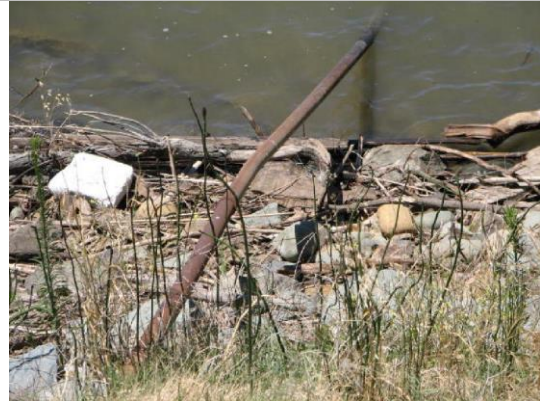
Photo 1 of 3 : UCIP\_SP\_2017\_51462\_20806.jpg

Comment Code					
Inspector Comment					
FS_ID:51462 DS_ID:17464 EP_NO: N/A Repair Type: Non-Urgent Crossing Status: Found UCIP Comments: 12/02/2016 Same as previous inspection. Need find owner. Owner will need to coordinate with the CVFPB to address what is currently logged as unauthorized encroachments. Owner will need to comply with Title 23. Dense vegetation limits the inspector's visibility to identify signs of pipe failure (leaks) along the slope. Recommend removing vegetation along pipe alignment to conduct proper inspection of structure and appurtenances. Crossing has been downgraded from "Urgent" to "Non-Urgent" due to modifications made to the UCIP repair/maintenance priority. (O. Magana - DWR UCIP)06/25/2012 No permit issued for this crossing and it is not an O+M entry. Abandoned pipe not grouted or sealed. (W. Wylie - DWR UCIP) FIELD_STRUCT_DESC: 2.25-inch steel water line through levee, 5 feet below crown. Gate valve located on the waterside (WS) slope has been removed. 2-inch steel pipe remains visible on the landside (LS) slope parallel to new 2.25-inch steel pipe. Pumphouse is located on the LS toe. [Additional Reference(s): DWR Levee Log, 1991]. FS Date: 12/2/2016

2.25-inch pipe at waterline.

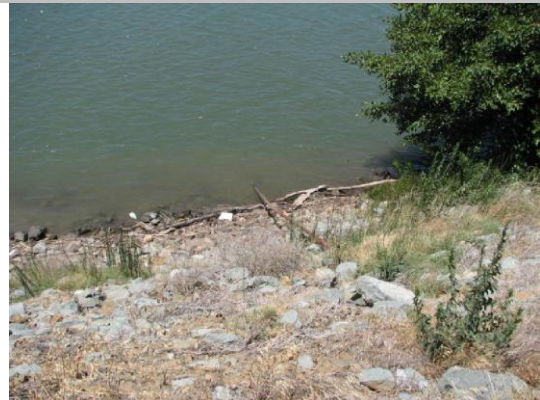
Photo 2 of 3 : UCIP\_SP\_2017\_51462\_20805.jpg

View of pipe from WS shoulder.

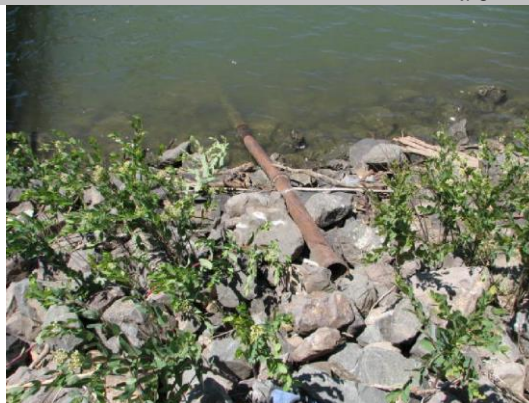
Photo 1 of 2 : UCIP\_SP\_2017\_5926\_9012.jpg

LM Start	14.75	Rating **	M	Issue No.	1829
LM End	14.75	Issue Type +	En	Location *	LS
Category	Supplemental			GPS Latitude/Longitude	
				Start	End
Item	DWR UCIP Field Study			38.404510 °	38.404510 °
				-121.513690 °	-121.513690 °
DWR ID					
Comment Code					
Inspector Comment					
FS_ID:5926 DS_ID:18958 EP_NO: N/A Repair Type: Non-Urgent Crossing Status: Found UCIP Comments: Pipe needs to be properly abandoned. FIELD_STRUCT_DESC: 4-inch cast iron pipe through levee, 18-feet below crown. Located 9-feet upstream from boat ramp walkway on waterward slope. FS Date: 6/25/2012 3:51:21 PM

Pipe on WS slope at waterline. Pipe not backfilled with grout.

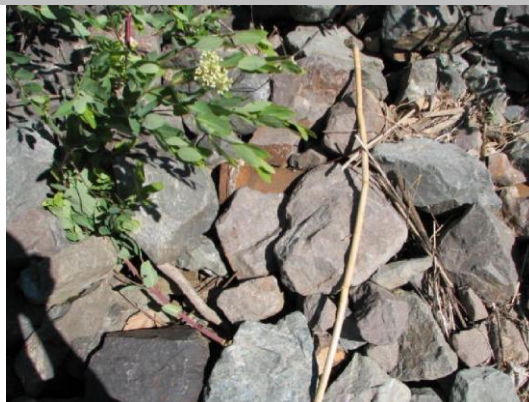
Photo 2 of 2 : UCIP\_SP\_2017\_5926\_9011.jpg

Pipe on WS slope.

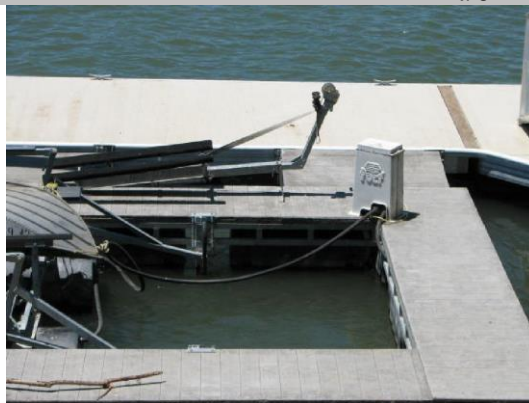
Photo 1 of 2 : UCIP\_SP\_2017\_5928\_9020.jpg

LM Start	14.76	Rating **	M	Issue No.	1830
LM End	14.76	Issue Type +	En	Location *	LS
Category	Supplemental			GPS Latitude/Longitude	
				Start	End
Item	DWR UCIP Field Study			38.404480 °	38.404480 °
				-121.513680 °	-121.513680 °
DWR ID					
Comment Code					
Inspector Comment					
FS_ID:5928 DS_ID:18959 EP_NO: N/A Repair Type: Non-Urgent Crossing Status: Found UCIP Comments: No permit identified for this crossing. FIELD_STRUCT_DESC: 1-inch PVC electrical conduit through the levee 1.5-feet below the crown at the upstream side of boat ramp walkway. Provides electrical service to boat ramp. FS Date: 6/25/2012 3:53:19 PM

Possible electrical conduit on boat dock.

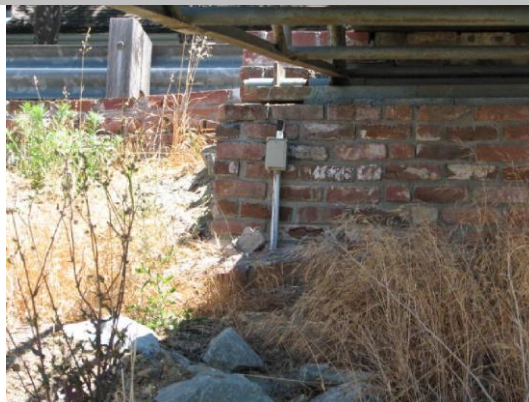
Photo 2 of 2 : UCIP\_SP\_2017\_5928\_9019.jpg

Electrical conduit at WS shoulder on upstream side of pier walkway.

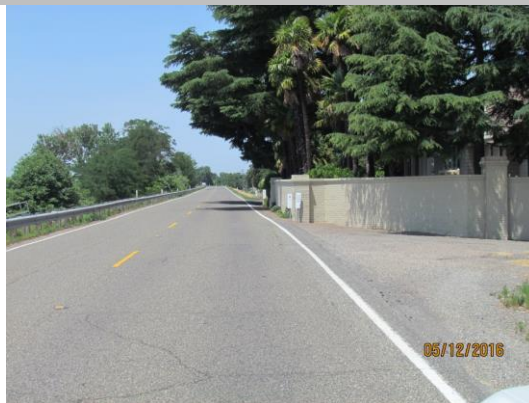
Photo 1 of 1 : SP\_2017\_MA0009\_201\_957\_20170320\_00300.jpg

LM Start	14.76	Rating **	M	Issue No.	957
LM End	14.76	Issue Type +	En	Location *	LS
Category	Earthen Levee			GPS Latitude/Longitude	
				Start	End
Item	Encroachments			38.404447 °	38.404447 °
				-121.513634 °	-121.513634 °
DWR ID	DWR_MA0009_01_s _ 2012_957				
Comment Code					
FE : Fence					
Inspector Comment					
Painted brick wall on landside shoulder.

View of the brick wall on the shoulder of the levee on the landward side looking upstream. Spring 2016.

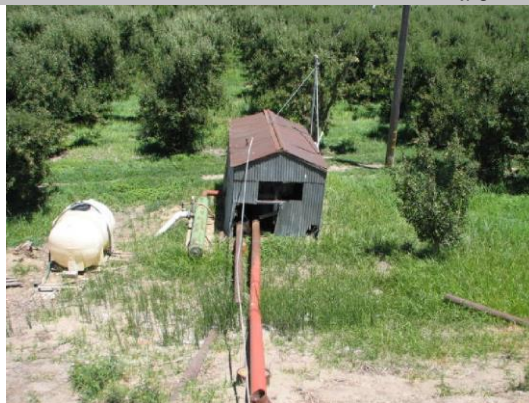
Photo 1 of 3 : UCIP\_SP\_2017\_5180\_7004.jpg

LM Start	15.04	Rating **	M	Issue No.	1831
LM End	15.04	Issue Type +	En	Location *	LS
Category	Supplemental			GPS Latitude/Longitude	
				Start	End
Item	DWR UCIP Field Study			38.400520 °	38.400520 °
				-121.512300 °	-121.512300 °
DWR ID					
Comment Code					
Inspector Comment					
FS_ID:5180 DS_ID:17429 EP_NO: 6189 Repair Type: Non-Urgent Crossing Status: Found UCIP Comments: Need to determine if additional pipe on LS slope is discarded material or an additional pipe through the levee. FIELD_STRUCT_DESC: 5-inch pipe sleeved through 7-inch pipe through levee, 8.4 feet below crown. Annular space grouted, pump and gate valve in pumphouse on landward side (App. No. 6189 11/15/1968). Originally included in O+M manual (1955). 1-inch pimer line runs to LS shoulder and 5-inch standpipe. FS Date: 6/25/2012 11:31:49 AM

Pumphouse, JP, and meter on LS toe. Showing 3 pipes on LS slope.

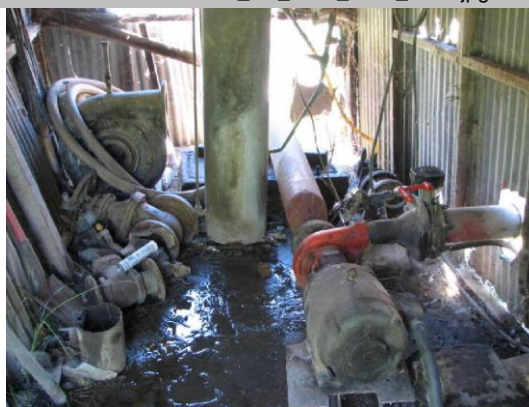
Photo 2 of 3 : UCIP\_SP\_2017\_5180\_7003.jpg

Pump in pumphouse on LS toe.

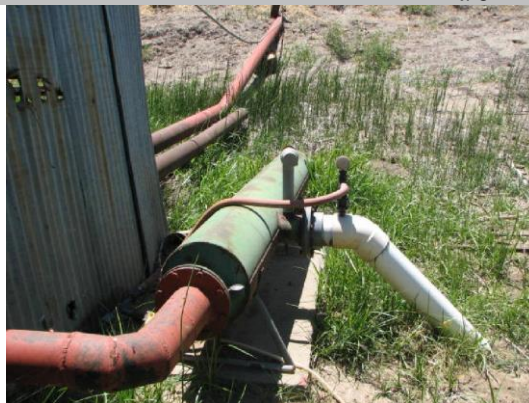
Photo 3 of 3 : UCIP\_SP\_2017\_5180\_7002.jpg

LM Start	15.04	Rating **	M	Issue No.	1831 (cont)
LM End	15.04	Issue Type +	En	Location *	LS
Category	Supplemental			GPS Latitude/Longitude	
				Start	End
Item	DWR UCIP Field Study			38.400520 °	38.400520 °
				-121.512300 °	-121.512300 °
DWR ID					
Comment Code					
Inspector Comment					
FS_ID:5180 DS_ID:17429 EP_NO: 6189 Repair Type: Non-Urgent Crossing Status: Found UCIP Comments: Need to determine if additional pipe on LS slope is discarded material or an additional pipe through the levee. FIELD_STRUCT_DESC: 5-inch pipe sleeved through 7-inch pipe through levee, 8.4 feet below crown. Annular space grouted, pump and gate valve in pumphouse on landward side (App. No. 6189 11/15/1968). Originally included in O+M manual (1955). 1-inch pimer line runs to LS shoulder and 5-inch standpipe. FS Date: 6/25/2012 11:31:49 AM

Distribution system on LS toe.

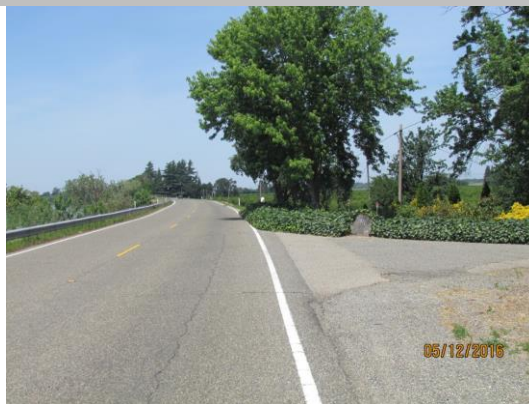
Photo 1 of 1 : SP\_2017\_MA0009\_201\_55\_20170320\_00041.jpg

LM Start	15.09	Rating **	M	Issue No.	55
LM End	15.09	Issue Type +	En	Location *	LS
Category	Earthen Levee			GPS Latitude/Longitude	
				Start	End
Item	Vegetation			38.399804 °	38.399804 °
				-121.512096 °	-121.512096 °
DWR ID	DWR_MA0009_01_s_2012_55				
Comment Code					
V6 : Landscaping					
Inspector Comment

View of the trees and ivy plants on the shoulder of the levee on the landward side looking upstream. Spring 2016.

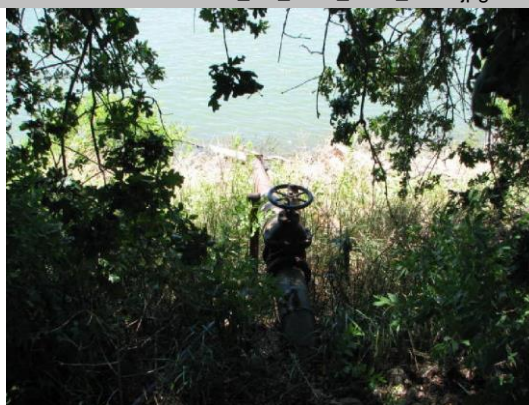
Photo 1 of 3 : UCIP\_SP\_2017\_5181\_7008.jpg

LM Start	15.19	Rating **	M	Issue No.	1832
LM End	15.19	Issue Type +	En	Location *	LS
Category	Supplemental			GPS Latitude/Longitude	
				Start	End
Item	DWR UCIP Field Study			38.398340 °	38.398340 °
				-121.511980 °	-121.511980 °
DWR ID					
Comment Code					
Inspector Comment					
FS_ID:5181					
DS_ID:17430					
EP_NO: N/A					
Repair Type: Non-Urgent					
Crossing Status: Found					
UCIP Comments: Gate valve on WS does not open or close.					
FIELD_STRUCT_DESC: 8-inch steel pipe through levee, 12.7 feet below crown. Joint pole, meter, 16-inch standpipe and pump on LS toe. Gatevalve on waterward slope. 1-inch galvanized steel primer pipe runs parallel to 8-inch pipe on LS slope. Originally included in O+M manual (1955).					
FS Date: 6/25/2012 11:56:42 AM

Gate valve on WS slope.

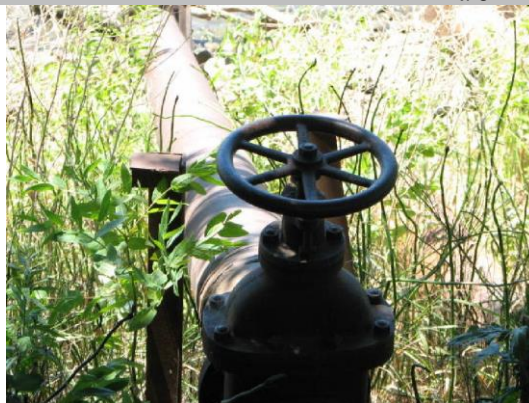
Photo 2 of 3 : UCIP\_SP\_2017\_5181\_7007.jpg

LM Start	15.19	Rating **	M	Issue No.	1832 (cont)	
LM End	15.19	Issue Type +	En	Location *	LS	
Category	Supplemental			GPS Latitude/Longitude		
				Start	End	
Item	DWR UCIP Field Study			38.398340 °	38.398340 °	
				-121.511980 °	-121.511980 °	
DWR ID						
Comment Code						
Inspector Comment						
FS_ID:5181						
DS_ID:17430						
EP_NO: N/A						
Repair Type: Non-Urgent						
Crossing Status: Found						
UCIP Comments: Gate valve on WS does not open or close.						
FIELD_STRUCT_DESC: 8-inch steel pipe through levee, 12.7 feet below crown. Joint pole, meter, 16-inch standpipe and pump on LS toe. Gatevalve on waterward slope. 1-inch galvanized steel primer pipe runs parallel to 8-inch pipe on LS slope. Originally included in O+M manual (1955).						
FS Date: 6/25/2012 11:56:42 AM

Close up of Gate valve on WS slope.

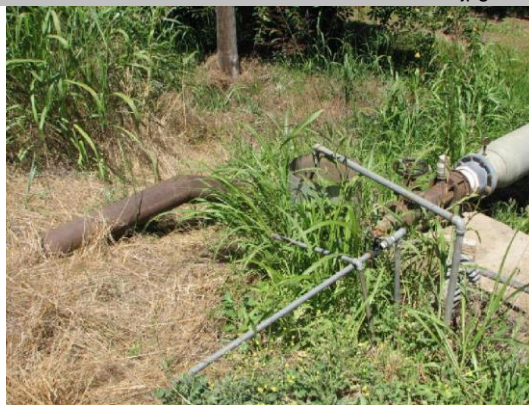
Photo 3 of 3 : UCIP\_SP\_2017\_5181\_7006.jpg

Pump, pipe, and appurtances on LS toe.

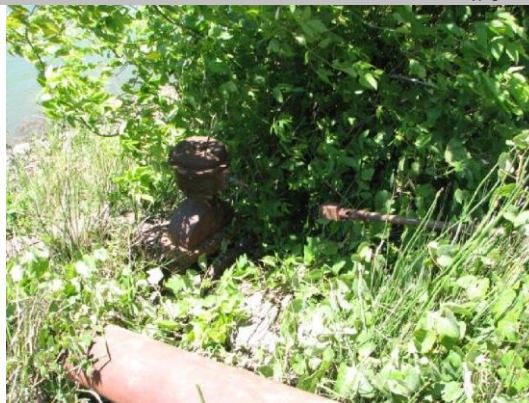
Photo 2 of 3 : UCIP\_SP\_2017\_51465\_20808.jpg

Comment Code					
Inspector Comment					
FS_ID:51465 DS_ID:17431 EP_NO: N/A Repair Type: Urgent Crossing Status: Found UCIP Comments: 12/02/2016 Assumed same condition as last inspection--unable to verify damage reported during last inspection due to limited access to both WS and LS (steep slopes--safety issue). Crossing remains "Urgent" due to signs of sink hole/burrow activity visible along WS pipe alignment. Need to contact owner. Recommend internal integrity inspection be performed at this crossing to determine condition of pipe through the levee. (O. Magana - DWR UCIP)06/25/2012 2-foot deep 5-foot diameter sink hole over pipe at LS shoulder. Pipe has multiple repairs and leaks along water side slope. gate valve is in-operative. Pipe is likely failing internally. (W. Wylie - DWR UCIP) FIELD_STRUCT_DESC: 12-inch steel irrigation pipe through levee, 17 feet below crown. Pump and gate valve on concrete stand box are located on the landside (LS) toe. Slant pump and 10-inch pipe sleeved into 12-inch pipe located on the waterside (WS) slope. [Additional Reference(s): DWR Levee Log, 1991. USACE Sacramento O&M Manual Unit 111, May 1959 (River Mile 40.34)]. FS Date: 12/2/2016

Gate valve missing handle.

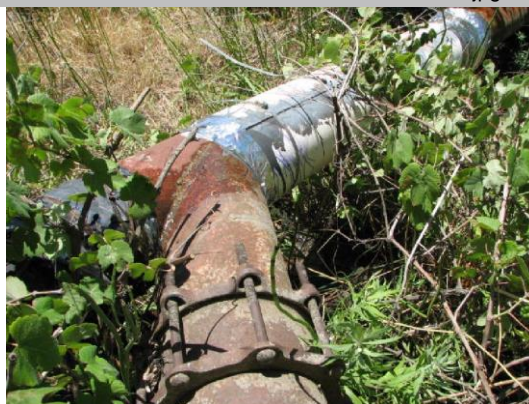
Photo 3 of 3 : UCIP\_SP\_2017\_51465\_20807.jpg

Pipe holes and patch job typical of large sections of pipe.

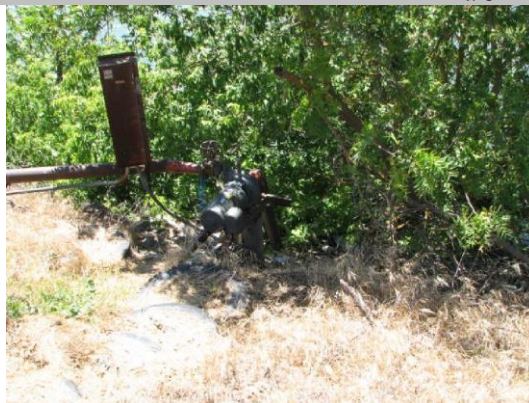
Photo 1 of 2 : UCIP\_SP\_2017\_41066\_7015.jpg

LM Start	15.80	Rating **	M	Issue No.	1834
LM End	15.80	Issue Type +	En	Location *	WS
Category	Supplemental			GPS Latitude/Longitude	
				Start	End
Item	DWR UCIP Field Study			38.389530 °	38.389530 °
				-121.512800 °	-121.512800 °
DWR ID					
Comment Code					
Inspector Comment					
FS_ID:41066 DS_ID:17432 EP_NO: N/A Repair Type: Non-Urgent Crossing Status: Indicator Found UCIP Comments: Pipe abandoned/grouted in place by DWR. Pipe not found but pump and appurtances good indicator of previous location. FIELD_STRUCT_DESC: *ABANDONED* 1 of 2: 8-inch abandoned pipe through levee, 12.7 feet below crown. Pressure grouted 8/68 by DWR. Originally included in O+M manual (1955). FS Date: 6/25/2012 1:39:00 PM

Pump at location where this pipe would have originally been located.

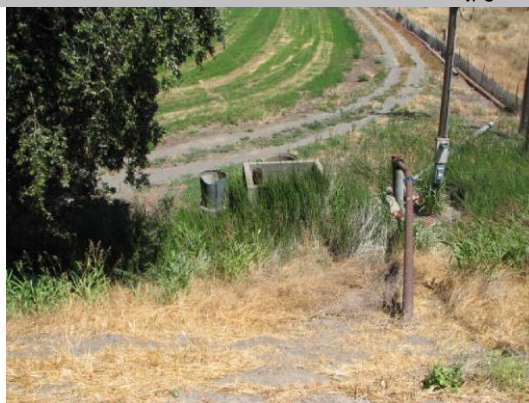
Photo 2 of 2 : UCIP\_SP\_2017\_41066\_7014.jpg

Concrete box and galvanized steel standpipe good indicator as to original pipe location.

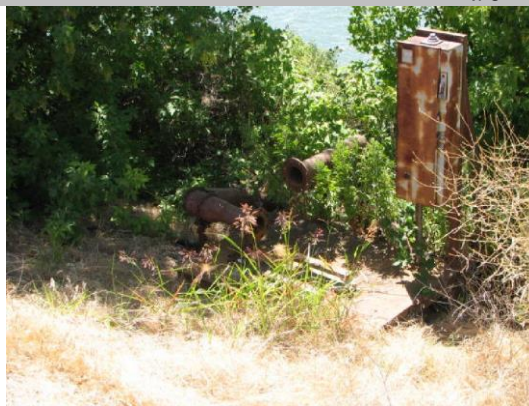
Photo 1 of 3 : UCIP\_SP\_2017\_51256\_20814.jpg

Comment Code					
Inspector Comment					
FS_ID:51256 DS_ID:17433 EP_NO: N/A Repair Type: Urgent Crossing Status: Found UCIP Comments: 12/02/2016 same as last inspection pipe has been abandoned. Crossing remains "Urgent" due to WS pipe inlet opened (unable to confirm--pipe has been disconnected). (O. Magana - DWR UCIP)06/25/2012 Pump and gate valve removed from pumphouse. Pipe needs to be closed or properly abandoned. (W. Wylie - DWR UCIP) FIELD_STRUCT_DESC: *ABANDONED* 8-inch steel irrigation pipe through levee, 13.3 feet below crown. Pump and gate valve missing from the waterside (WS) slope. Service pole and concrete distribution box located at the toe of landside (LS) slope. 1-inch galvanized steel electrical conduit through the levee parallel to the 8-inch pipe. [Additional Reference(s): DWR Levee Log, 1991. USACE Sacramento O&M Manual Unit 111, May 1959 (River Mile 39.99). FS Date: 12/2/2016

WS shoulder: pumphouse missing walls, pump, and gate valve

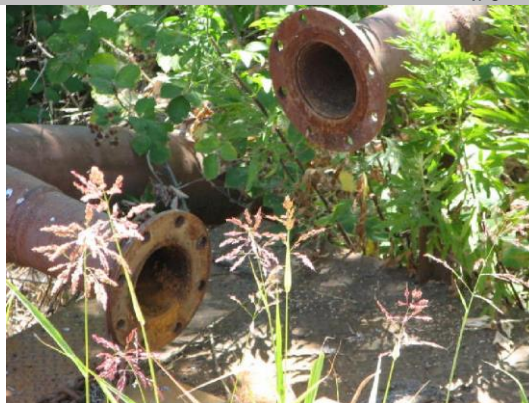
Photo 2 of 3 : UCIP\_SP\_2017\_51256\_20813.jpg

FS\_ID:51256  
DS\_ID:17433  
EP\_NO: N/A  
Repair Type: Urgent  
Crossing Status: Found  
UCIP Comments: 12/02/2016 same as last inspection pipe has been abandoned. Crossing remains "Urgent" due to WS pipe inlet opened (unable to confirm--pipe has been disconnected). (O. Magana - DWR UCIP)06/25/2012 Pump and gate valve removed from pumphouse. Pipe needs to be closed or properly abandoned. (W. Wylie - DWR UCIP)  
FIELD\_STRUCT\_DESC: \*ABANDONED\* 8-inch steel irrigation pipe through levee, 13.3 feet below crown. Pump and gate valve missing from the waterside (WS) slope. Service pole and concrete distribution box located at the toe of landside (LS) slope. 1-inch galvanized steel electrical conduit through the levee parallel to the 8-inch pipe.  
[Additional Reference(s): DWR Levee Log, 1991. USACE Sacramento O&M Manual Unit 111, May 1959 (River Mile 39.99).  
FS Date: 12/2/2016

Open pipe where pump and gate valve should be located.

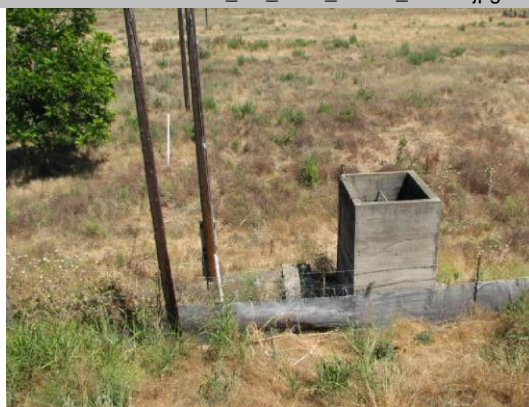
Photo 3 of 3 : UCIP\_SP\_2017\_51256\_20812.jpg

Pipe, JP, meter, and concrete distribution box on LS toe.

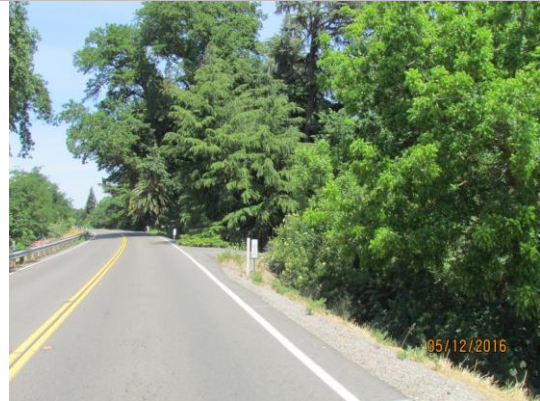
Photo 1 of 1 : SP\_2017\_MA0009\_201\_202\_20170320\_00165.jpg

LM Start	15.96	Rating **	M	Issue No.	202
LM End	16.12	Issue Type +	En	Location *	LS
Category	Earthen Levee			GPS Latitude/Longitude	
				Start	End
Item	Vegetation			38.387379 °	38.385235 °
				-121.513615 °	-121.515025 °
DWR ID	DWR_MA0009_01_s_2012_202				
Comment Code					
V6 : Landscaping					
Inspector Comment					
Rosebud and house upstream

View of the trees on the landward slope of the levee looking upstream.  
Spring 2016.

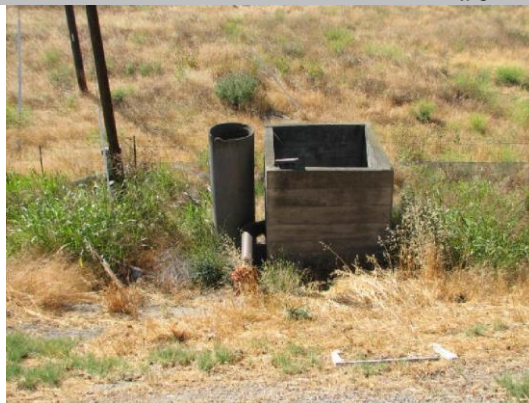
Photo 1 of 3 : UCIP\_SP\_2017\_5186\_7023.jpg

LM Start	16.15	Rating **	M	Issue No.	1836
LM End	16.15	Issue Type +	En	Location *	LS
Category	Supplemental			GPS Latitude/Longitude	
				Start	End
Item	DWR UCIP Field Study			38.384990 °	38.384990 °
				-121.515280 °	-121.515280 °
DWR ID					
Comment Code					
Inspector Comment					
FS_ID:5186 DS_ID:17434 EP_NO: N/A Repair Type: Non-Urgent Crossing Status: Found UCIP Comments: Pump missing from platform. FIELD_STRUCT_DESC: 8-inch pipe through levee, 11.8 feet below crown. Slant pump on waterward slope. gate valve, 24-inch concrete standpipe, anc concrete distribution box on LS toe. Meter on pole LS toe. 1-inch galvanized steel electrical conduit through the levee 11.8 feet below the crown. Originally included in O+M manual (1955). FS Date: 6/26/2012 2:02:36 PM

Gate valve, standpipe, concrete distribution box, pole, and meter on LS toe.

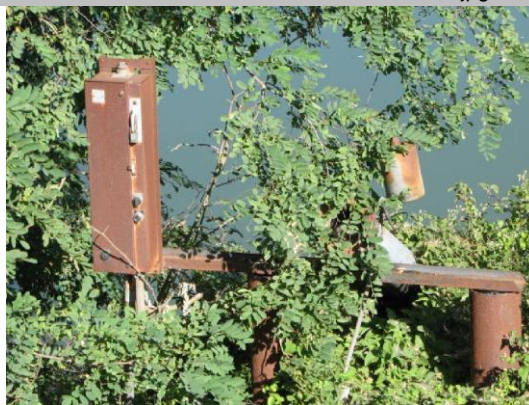
Photo 2 of 3 : UCIP\_SP\_2017\_5186\_7022.jpg

Open pumphouse with breaker and missing pump shown.

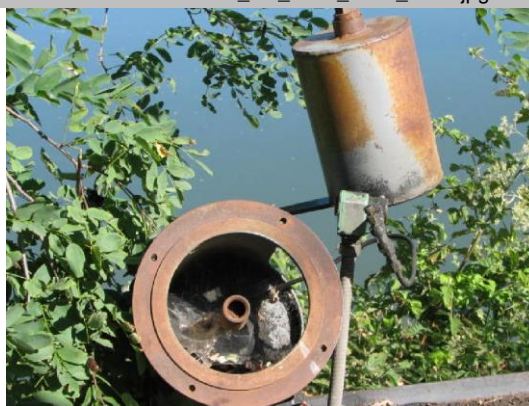
Photo 3 of 3 : UCIP\_SP\_2017\_5186\_7021.jpg

LM Start	16.15	Rating **	M	Issue No.	1836 (cont)	
LM End	16.15	Issue Type +	En	Location *	LS	
Category	Supplemental			GPS Latitude/Longitude		
				Start	End	
Item	DWR UCIP Field Study			38.384990 °	38.384990 °	
				-121.515280 °	-121.515280 °	
DWR ID						
Comment Code						
Inspector Comment						
FS_ID:5186						
DS_ID:17434						
EP_NO: N/A						
Repair Type: Non-Urgent						
Crossing Status: Found						
UCIP Comments: Pump missing from platform.						
FIELD_STRUCT_DESC: 8-inch pipe through levee, 11.8 feet below crown. Slant pump on waterward slope. gate valve, 24-inch concrete standpipe, anc concrete distribution box on LS toe. Meter on pole LS toe. 1-inch galvanized steel electrical conduit through the levee 11.8 feet below the crown. Originally included in O+M manual (1955).						
FS Date: 6/26/2012 2:02:36 PM

Missing pump.

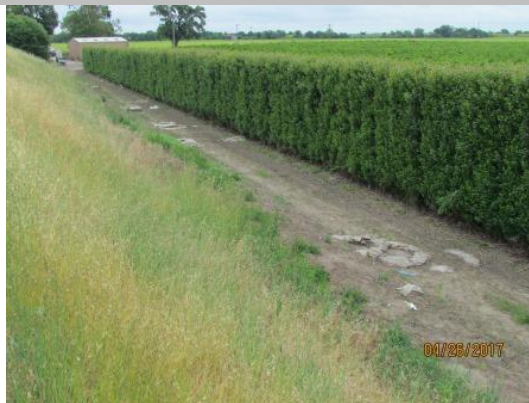
Photo 1 of 1 : SP\_2017\_MA0009\_201\_344\_20170426\_00514.jpg

LM Start	16.54	Rating **	A	Issue No.	344
LM End	16.58	Issue Type +	Ob	Location *	LS
Category	Earthen Levee			GPS Latitude/Longitude	
				Start	End
Item	Seepage / Sandboils			38.381268 °	38.380964 °
				-121.520732 °	-121.521309 °
DWR ID	DWR_MA0009_01_s_2017_344				
Comment Code					
Inspector Comment					
Multiple boils at landside levee toe observed during winter high water.

View of boils at landside levee toe. Spring 2017.

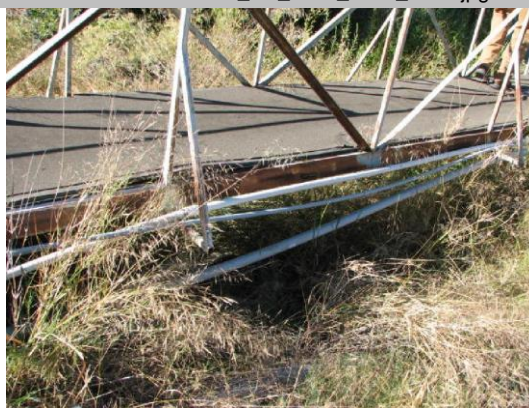
Photo 1 of 2 : UCIP\_SP\_2017\_5929\_9022.jpg

LM Start	17.10	Rating **	M	Issue No.	1837
LM End	17.10	Issue Type +	En	Location *	LS
Category	Supplemental			GPS Latitude/Longitude	
				Start	End
Item	DWR UCIP Field Study			38.374100 °	38.374100 °
				-121.522350 °	-121.522350 °
DWR ID					
Comment Code					
Inspector Comment					
FS_ID:5929 DS_ID:18960 EP_NO: N/A Repair Type: Non-Urgent Crossing Status: Found UCIP Comments: No permit identified for this crossing. FIELD_STRUCT_DESC: 1.25-inch PVC pipe through the levee 6-feet below the crown at the upstream side of boat ramp walkway. FS Date: 6/26/2012 3:56:24 PM

Pipe on upstream side of pier walkway.

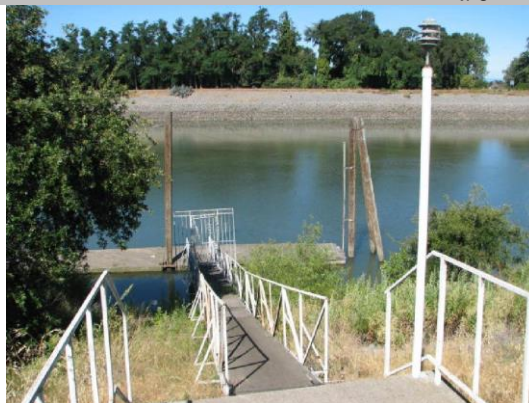
Photo 2 of 2 : UCIP\_SP\_2017\_5929\_9021.jpg

Pier on WS shoulder.

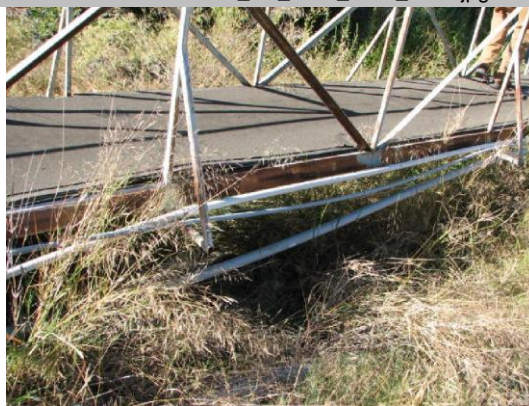
Photo 1 of 2 : UCIP\_SP\_2017\_5930\_9024.jpg

LM Start	17.10	Rating **	M	Issue No.	1838
LM End	17.10	Issue Type +	En	Location *	LS
Category	Supplemental			GPS Latitude/Longitude	
				Start	End
Item	DWR UCIP Field Study			38.374080 °	38.374080 °
				-121.522360 °	-121.522360 °
DWR ID					
Comment Code					
Inspector Comment					
FS_ID:5930 DS_ID:18961 EP_NO: N/A Repair Type: Non-Urgent Crossing Status: Found UCIP Comments: No permit identified for this crossing. FIELD_STRUCT_DESC: 0.75-inch PVC pipe through the levee 6-feet below the crown at the upstream side of boat ramp walkway. FS Date: 6/26/2012 3:58:33 PM

Pipes on upstream side of pier walkway.

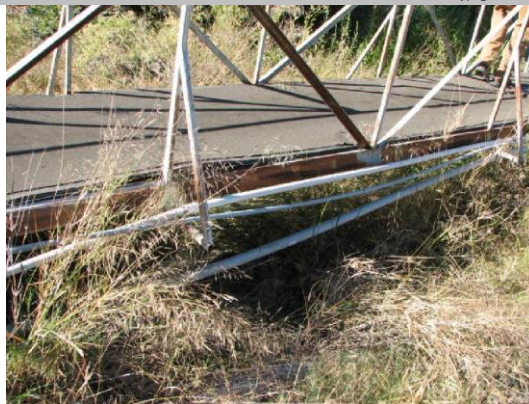
Photo 1 of 2 : UCIP\_SP\_2017\_5945\_9086.jpg

LM Start	17.11	Rating **	M	Issue No.	1839
LM End	17.11	Issue Type +	En	Location *	LS
Category	Supplemental			GPS Latitude/Longitude	
				Start	End
Item	DWR UCIP Field Study			38.374070 °	38.374070 °
				-121.522360 °	-121.522360 °
DWR ID					
Comment Code					
Inspector Comment					
FS_ID:5945 DS_ID:18962 EP_NO: N/A Repair Type: Non-Urgent Crossing Status: Found UCIP Comments: No permit identified for this crossing. FIELD_STRUCT_DESC: 2-inch PVC pipe through the levee 6-feet below the crown at the upstream side of boat ramp walkway. FS Date: 6/26/2012 3:59:00 PM

Pipes on upstream side of pier walkway.

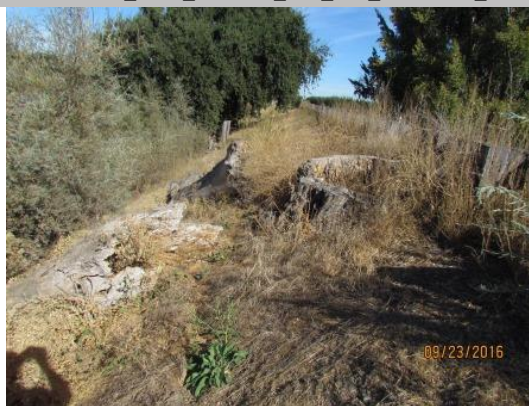
Photo 1 of 1 : SP\_2017\_MA0009\_201\_258\_20170320\_00201.jpg

LM Start	17.20	Rating **	N	Issue No.	258
LM End	17.20	Issue Type +	Ma	Location *	WS
Category	Earthen Levee			GPS Latitude/Longitude	
				Start	End
Item	Trim / Thin Trees			38.372762 °	38.372762 °
				-121.521774 °	-121.521774 °
DWR ID	DWR_MA0009_01_f_2016_258				
Comment Code					
T5 : Tree stumps.					
Inspector Comment					
May pose threat to the levee in future.

Decomposing tree body and root on waterside slope looking upstream.  
Fall 2016.

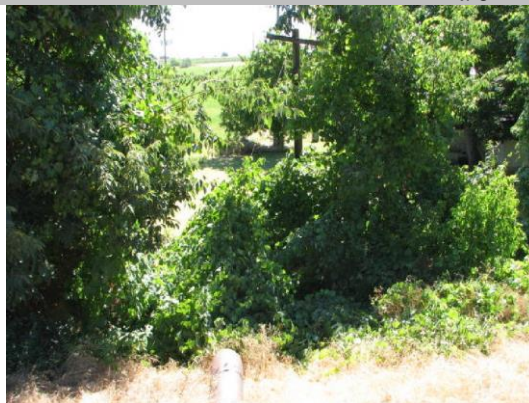
Photo 1 of 3 : UCIP\_SP\_2017\_5222\_7111.jpg

LM Start	17.36	Rating **	M	Issue No.	1840
LM End	17.36	Issue Type +	En	Location *	WS
Category	Supplemental			GPS Latitude/Longitude	
				Start	End
Item	DWR UCIP Field Study			38.370596 °	38.370596 °
				-121.520907 °	-121.520907 °
DWR ID					
Comment Code					
Inspector Comment					
FS_ID:5222 DS_ID:17452 EP_NO: N/A Repair Type: Non-Urgent Crossing Status: Found UCIP Comments: Pump disconnected from pipe in pumphouse. FIELD_STRUCT_DESC: 8-inch steel pipe sleeved through 10-inch pipe on WS and 10-inch pipe sleeved through 12-inch pipe on LS, 6.0 feet below crown. Pump disconnected and gate valve in pumphouse on waterward slope. 1.5-inch steel electrical conduit through the levee and parallel to the 8-inch steel pipe. Originally included in O+M manual (1955). FS Date: 6/26/2012 3:02:29 PM

Concrete standpipe under heavy vegetation at LS toe.

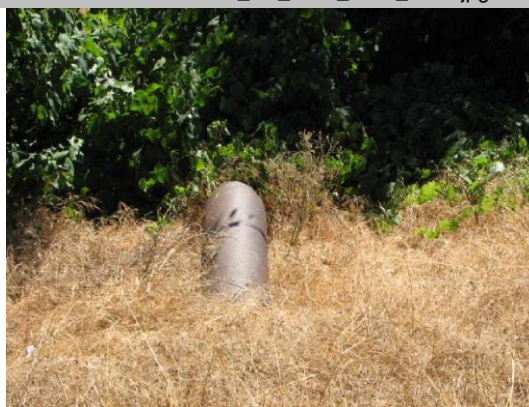
Photo 2 of 3 : UCIP\_SP\_2017\_5222\_7110.jpg

10-inch sleeved through a 12-inch pipe on the LS shoulder.

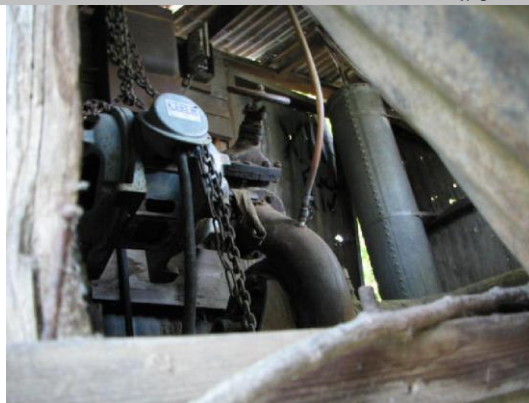
Photo 3 of 3 : UCIP\_SP\_2017\_5222\_7109.jpg

LM Start	17.36	Rating **	M	Issue No.	1840 (cont)
LM End	17.36	Issue Type +	En	Location *	WS
Category	Supplemental			GPS Latitude/Longitude	
				Start	End
Item	DWR UCIP Field Study			38.370596 °	38.370596 °
				-121.520907 °	-121.520907 °
DWR ID					
Comment Code					
Inspector Comment					
FS_ID:5222 DS_ID:17452 EP_NO: N/A Repair Type: Non-Urgent Crossing Status: Found UCIP Comments: Pump disconnected from pipe in pumphouse. FIELD_STRUCT_DESC: 8-inch steel pipe sleeved through 10-inch pipe on WS and 10-inch pipe sleeved through 12-inch pipe on LS, 6.0 feet below crown. Pump disconnected and gate valve in pumphouse on waterward slope. 1.5-inch steel electrical conduit through the levee and parallel to the 8-inch steel pipe. Originally included in O+M manual (1955). FS Date: 6/26/2012 3:02:29 PM

Pump removed from pipe inside pumphouse on WS.

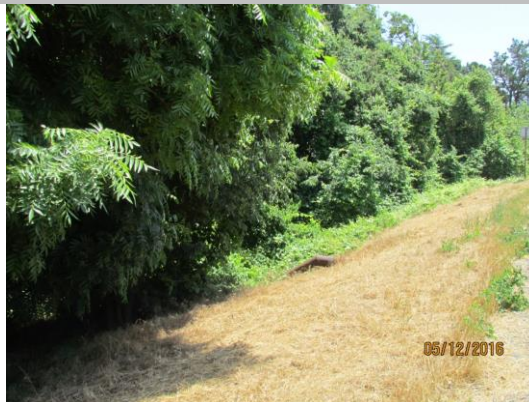
Photo 1 of 1 : SP\_2017\_MA0009\_201\_199\_20170320\_00162.jpg

LM Start	17.37	Rating **	M	Issue No.	199
LM End	17.37	Issue Type +	En	Location *	LS
Category	Earthen Levee			GPS Latitude/Longitude	
				Start	End
Item	Vegetation			38.370453 °	38.370453 °
				-121.520878 °	-121.520878 °
DWR ID	DWR_MA0009_01_s_2017_199				
Comment Code					
V6 : Landscaping					
Inspector Comment

View of the trees and shrubs on the landward side of the levee looking downstream. Spring 2016.

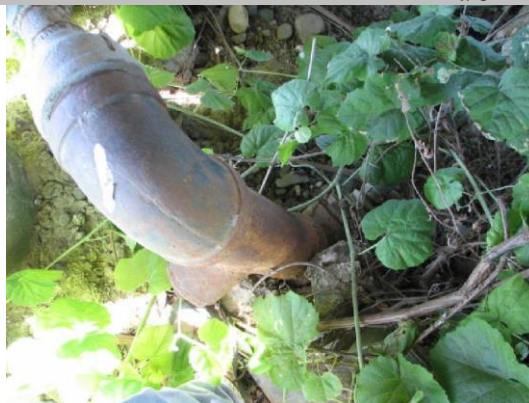
Photo 1 of 3 : UCIP\_SP\_2017\_5933\_9043.jpg

LM Start	17.49	Rating **	M	Issue No.	1842
LM End	17.49	Issue Type +	En	Location *	LS
Category	Supplemental			GPS Latitude/Longitude	
				Start	End
Item	DWR UCIP Field Study			38.368740 °	38.368740 °
				-121.520400 °	-121.520400 °
DWR ID					
Comment Code					
Inspector Comment					
FS_ID:5933 DS_ID:18964 EP_NO: N/A Repair Type: Non-Urgent Crossing Status: Found UCIP Comments: No permit identified for this crossing. FIELD_STRUCT_DESC: 4-inch steel waterline 3.5-feet below the crown. Shutoff valve on waterside slope under building. FS Date: 6/26/2012 4:02:26 PM

Pipe under walkway of building on WS slope.

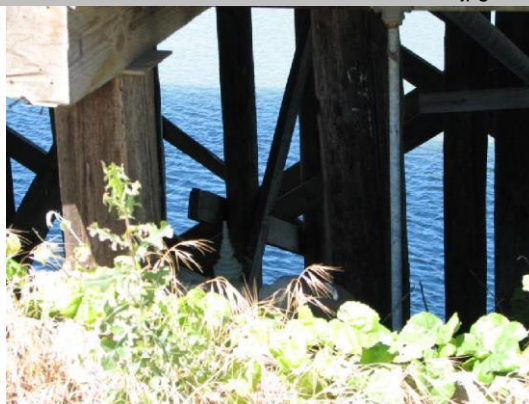
Photo 2 of 3 : UCIP\_SP\_2017\_5933\_9042.jpg

Valve sticking up under building on WS slope.

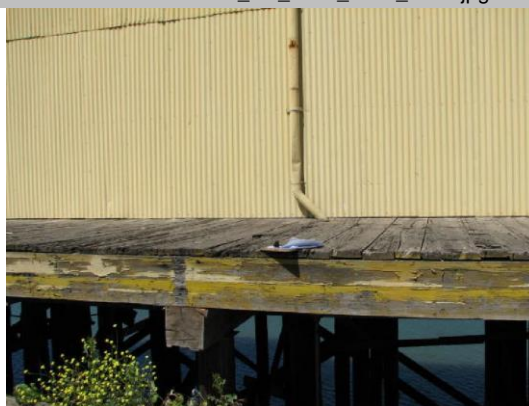
Photo 3 of 3 : UCIP\_SP\_2017\_5933\_9041.jpg

LM Start	17.49	Rating **	M	Issue No.	1842 (cont)
LM End	17.49	Issue Type +	En	Location *	LS
Category	Supplemental			GPS Latitude/Longitude	
				Start	End
Item	DWR UCIP Field Study			38.368740 °	38.368740 °
				-121.520400 °	-121.520400 °
DWR ID					
Comment Code					
Inspector Comment					
FS_ID:5933 DS_ID:18964 EP_NO: N/A Repair Type: Non-Urgent Crossing Status: Found UCIP Comments: No permit identified for this crossing. FIELD_STRUCT_DESC: 4-inch steel waterline 3.5-feet below the crown. Shutoff valve on waterside slope under building. FS Date: 6/26/2012 4:02:26 PM

Building at waterside slope.

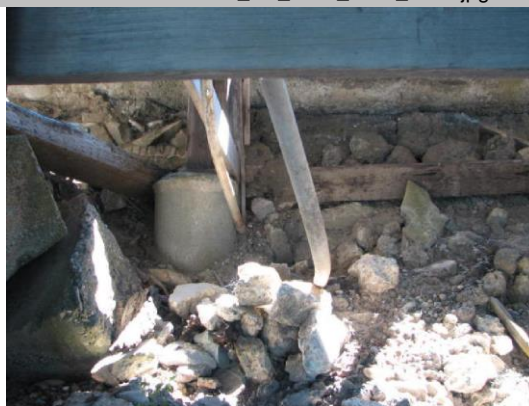
Photo 1 of 2 : UCIP\_SP\_2017\_5934\_9045.jpg

LM Start	17.50	Rating **	M	Issue No.	1843
LM End	17.50	Issue Type +	En	Location *	LS
Category	Supplemental			GPS Latitude/Longitude	
				Start	End
Item	DWR UCIP Field Study			38.368590 °	38.368590 °
				-121.520310 °	-121.520310 °
DWR ID					
Comment Code					
Inspector Comment					
FS_ID:5934 DS_ID:18965 EP_NO: N/A Repair Type: Non-Urgent Crossing Status: Found UCIP Comments: No permit identified for this crossing. FIELD_STRUCT_DESC: 2.5-inch steel electrical conduit 6-feet below the crown. Pipe visible under building on WS slope. FS Date: 6/26/2012 4:04:34 PM

Pipes through levee on WS slope.
